HIGH CURRENT ESD DAMAGE TO MOS I/O STRUCTURES
CAUSED BY CHARGED VIDEO MONITOR SURFACES AND CASINGS

ABSTRACT

A case study of a high current ESD phenomenon associated with handling MOS ICs in the vicinity of charged computer CRT terminals is presented. Component I/O metal damage occurred on an automotive module assembly line, and required special circuit modeling to explain and reproduce the damage. The phenomenon, the model, and the corrective design solution are discussed.

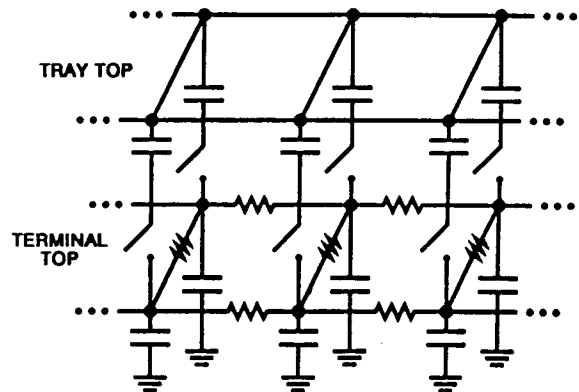
Soon the possibilities narrowed to the handling and storing of modules (modules are board-level units containing the custom SRAM) on the assembly line. A visiting Intel engineer observed that excess modules were removed from the assembly line, stacked on metal trays, and stored where space permitted until later. One noteworthy storage location for the trays was on the tops of computer terminals near the assembly line. This gave rise to the notion that a large amount of positive charge (due to the positive accelerating voltage of a CRT) was collected by the tray and modules, somehow causing the SRAM damage when it was dissipated.

Figure 2: Tray/Terminal top charge coupling schematic.

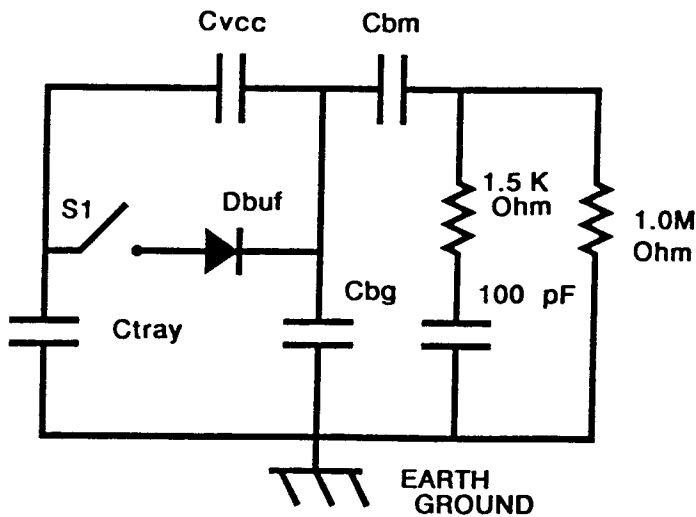
Our model was derived by characterization of the ESD event. Figure 3 is our basic model (scenario #1). Figure 4 illustrates our model applied to the 3 scenarios. The values of the components were measured or derived directly from the module itself where the custom SRAM is used. Most of the capacitor and resistor component values were measured with an LCR meter and other capacitance values were calculated from storage scope traces of a capacitive discharge through a known resistor. Following are the circuit elements used in Figure 3:

Figure 3: Basic circuit model of ESD phenomenon (Scenario #1)

Our primary scenario (#1) happens in the following way. An empty tray, sitting on top of computer display terminal, collects charge and reaches voltage V_{tray} , which can be thousands of volts. When the worker touches the module and slides it onto the tray, the module is angled so that the backside of the PC traces touches or an arc occurs between the PC traces and the tray (closing switch 1) causing the tray top to discharge C_{tray} and C_{voo} through the component to the worker. (Note that C_{bm} is quite large and behaves almost as a short.) In this model of scenario #1, a machine model-like event best describes the discharge of C_{voo} . When the arc forms to charge V_{oo} , charge passes through the diode D_{buf} to neutralize the voltage across C_{voo} . C_{voo} is dependent on the module's distance from the tray top, but in its final position C_{voo} is the highest (as readily measured and shown in the figures), and any charge on C_{voo} in that position will have to be dissipated. C_{voo} at 78 pf is at about 40% of the usual machine model value of 200 pf (Figure 5), so the machine model (MM) failure voltages would have to be scaled up to be equivalent to this case. If the failure relates to total energy in the capacitor (as we will argue is likely), the voltage scale factor between the MM and the module arc event would be about 1.6 (square root of the capacitance ratio).

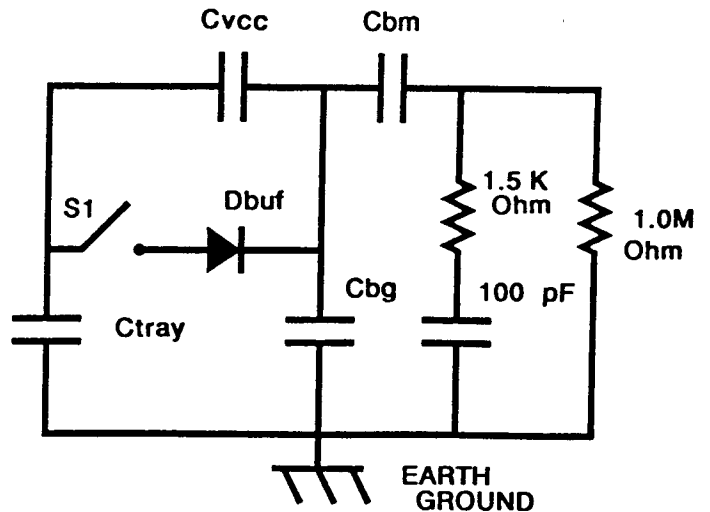
Figure 4a: Circuit model of Scenario #1. Someone lays an uncharged module on an empty charged tray sitting on top of a terminal.

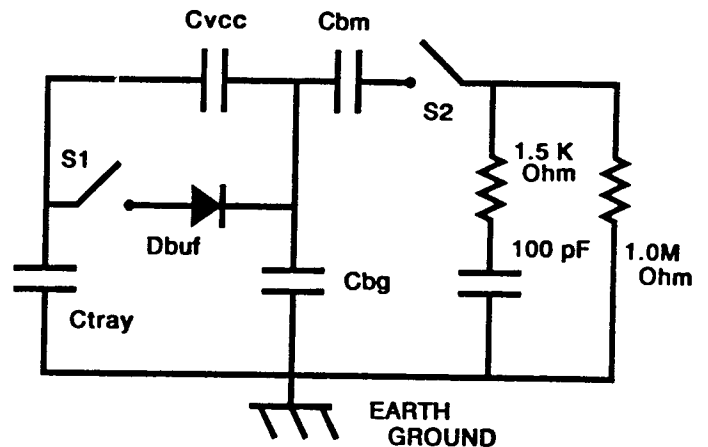
Figure 4b: Circuit model of Scenario #2. Someone touches a charged module on a storage tray sitting on top of a terminal.

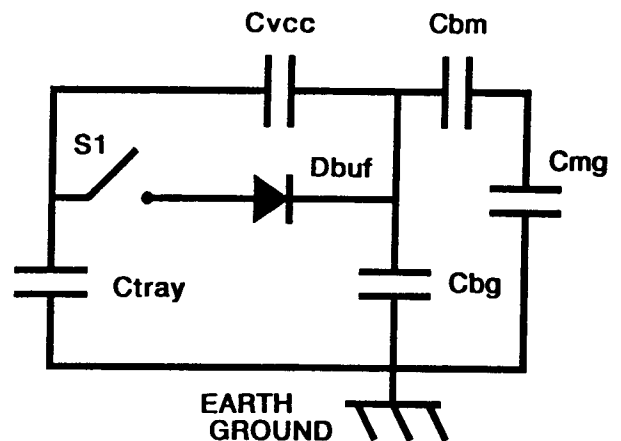
Figure 4c: Circuit model of Scenario #3. An uncharged module sits on top of a terminal and the tray arcs to it.

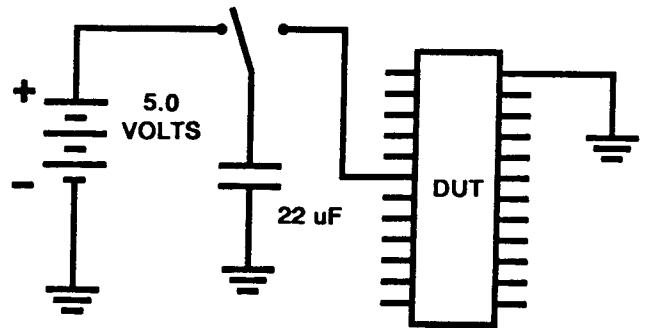
Figure 6: Bench top re-creation, 22 uF capacitor charged to 5.0 Volts and discharged into DUT.

We arrived at the values for the bench top simulation after characterizing the output driver P/N junction on the curve tracer. A constant 800 mA of current caused the I/O buffer P/N junction (with an "on" resistance of 4 ohms) to fail. 5 volts and 22 uF was a somewhat arbitrary choice of RC discharge conditions that delivered a measured quantity of charge with similar voltages and currents, and did cause destruction resembling that of the units returned from the assembly line. The RC of this circuit with the "on" diode resistance was 88.0 uS, the average instantaneous current, Q/RC , was 1.25 Amps, and the available stored energy, was 275 uJ.

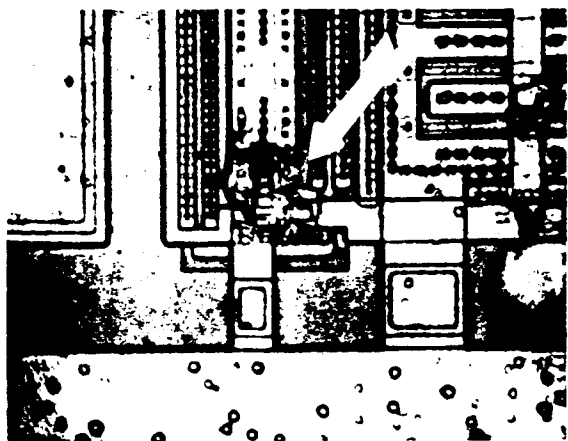
From about +900-1500 V on the machine model (negative zaps do not cause failure until much higher voltages, and do not relate to our damage model), there was little visible damage and failure was due to leakage current above the specification limit of 1 uA. Around 1500 V and above we began to see the same failure characteristics in the same failure location as in the returned units from the factory floor (Figure 7; note similarity to

Figure 1). As we approached 3000 volts, the leadway metal line from the bond pad ruptured and evaporated. All the MM capacitor energies in the higher voltage tests were in the same range of energies as the 22 uF model. For example, the MM tests at 900V and 1500V, respectively, produced 81 uJ and 225 uJ, which is just below but approaching the 275 uJ destruction energy of the 22 uF model. This also supports the notion that MM capacitor energy, not voltage, determines the failure, and means that MM voltages should be multiplied by 1.6 (square root of capacitance ratio, see Section III) to be equivalent to our "real world" model. We thus conclude that high voltage machine model events were destroying the parts. This is quite acceptable, as there is no requirement for such physical phenomena as metal tray discharge to occur at the threshold of destruction of our component!

Figure 7: Photograph of blown output metal lines from high voltage Machine Model testing. Note similarity to Figure 1, return part from customer.
