HIGH CURRENT ESD DAMAGE TO MOS I/O STRUCTURES
CAUSED BY CHARGED VIDEO MONITOR SURFACES AND CASINGS

ABSTRACT

A case study of a high current ESD phenomenon associated with handling MOS ICs in the vicinity of charged computer CRT terminals is presented. Component I/O metal damage occurred on an automotive module assembly line, and required special circuit modeling to explain and reproduce the damage. The phenomenon, the model, and the corrective design solution are discussed.

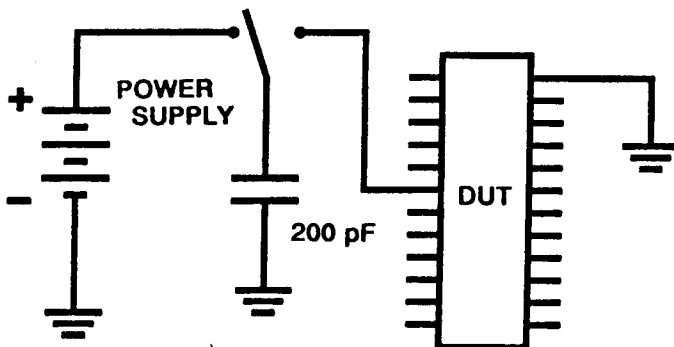
Figure 5: Machine Model, 200 pF capacitor and zero resistance to DUT

We also see an HBM event after C_{voo} discharges. C_{bm} acts as a virtual short as C_{tray} charges up the person holding the module. This is an HBM event as far as D_{buf} is concerned, although the equivalent voltage is about half the voltage on the tray, since C_{tray} is about equal to the HBM capacitance.
